**Healthy Hospital Design and Water Supply
– the case of Kolandoto Hospital in Tanzania**

Engineering Aid in Practice and its Challenges

A case study on improvements of water and power systems at a hospital in Tanzania

Master's Thesis in the Master's Programme Infrastructure and Environmental Engineering

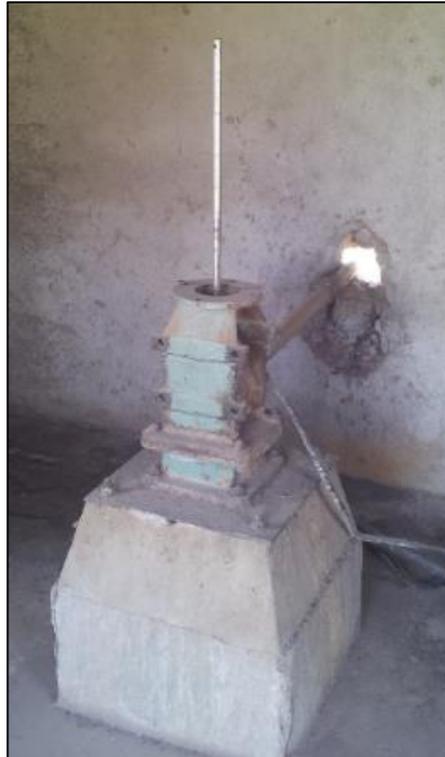
Figure 2: Image of BH2, not currently in use.

BH2 has not been in use since 1997 due to issues regarding the malfunction of the pump. Staff mentioned that the pump was heated causing it to malfunction. However, a full pipe network is installed but not in use. The water staff tried to repair the pump and use the borehole three years ago, but the pump malfunctioned due to heating once again. An option is to install a hand pump in BH2, allowing villagers living close to extract water directly from the well. BH2 is illustrated in Figure 2.

Further information on BH2 has been found in (some) reports conducted for the hospital (Shinyanga Municipal Council, 2010). The specifications regarding the borehole differs slightly between the reports, with information on depth ranging from 35 – 37 m and yield at 1.5 – 3.2 m³/h. Fluoride content is estimated to be 12 ppm, which is almost the same as in BH1. The reports also states particles in the groundwater as the main reason for the malfunction of the pump. A submersible pump is therefore considered unsuitable.

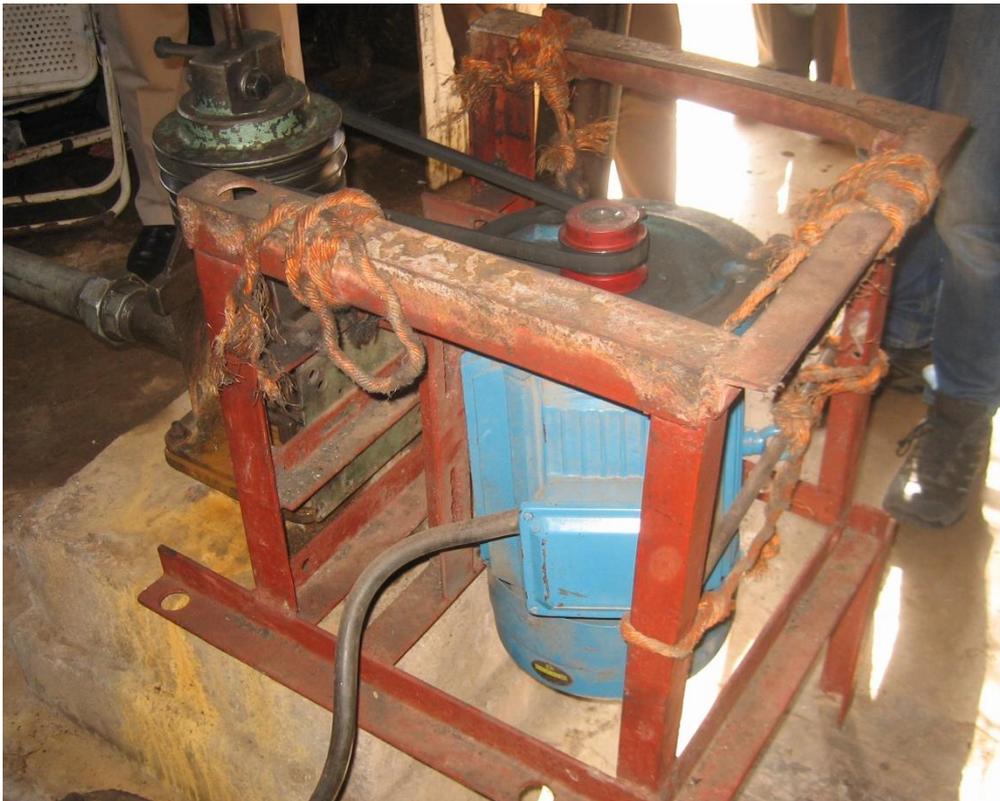
Figure 3: Old screw-pump currently in use at BH1.

An old pump, which is made from spare parts from two old pumps are used to extract water from BH1, see Figure 3. The type is a mono-pump where pipes formed as screws are inserted to the borehole and an engine located at the surface forces the water up from the borehole. Due to abrasion and age, the pump breaks a lot. Consumables are of poor quality since spare parts of good quality is rare. The pump screw is located at 18 m below surface.

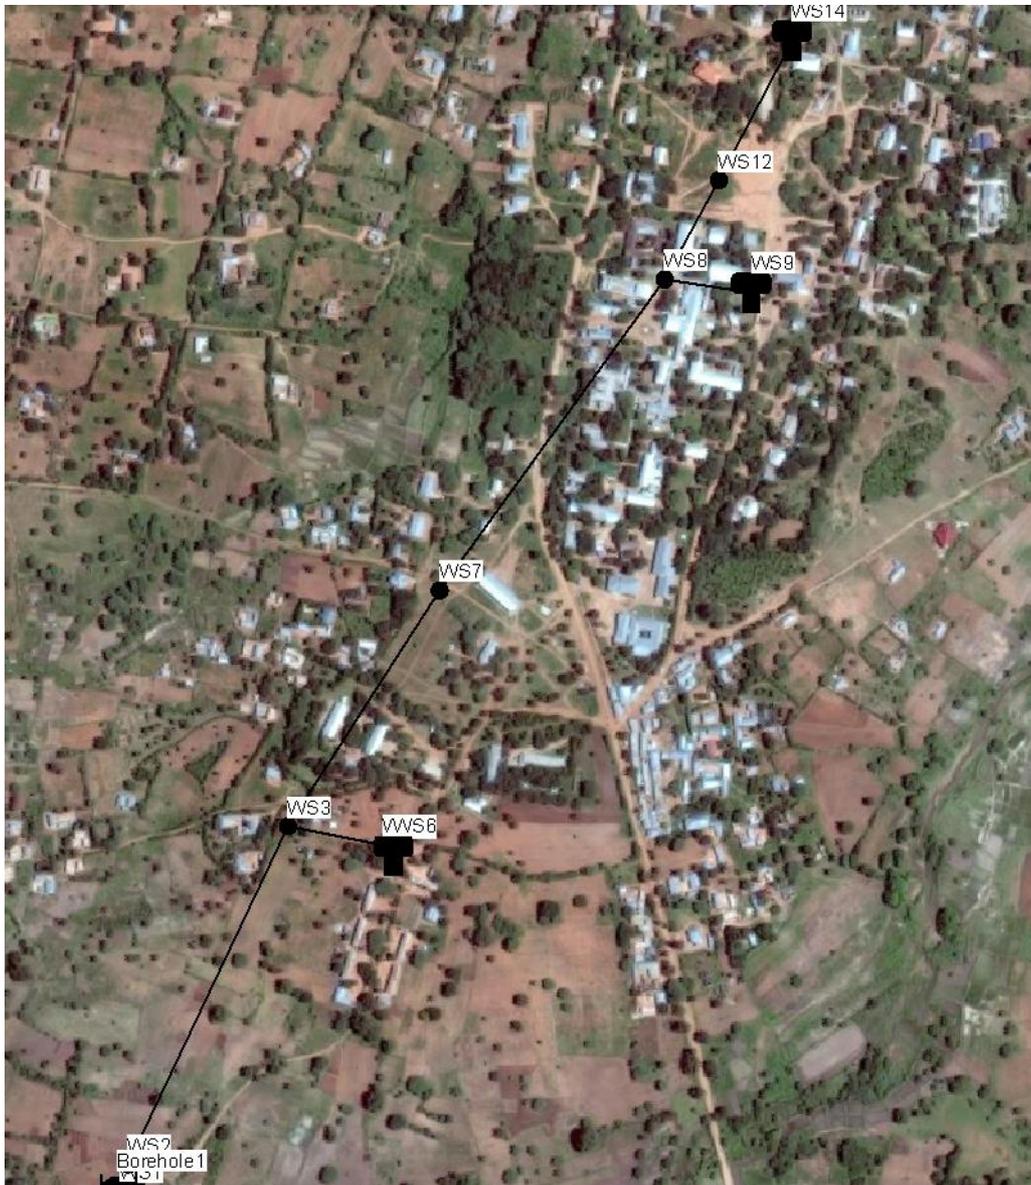
Figure 4: Supply network from borehole to tanks, from EPANET-model (backdrop from maps.google.com)

The distribution network has been mapped, using a GPS, and modelled in the software EPANET. In Figure 4 an overview of the system is shown, with the location of the borehole and the three tanks. Descriptions are presented in Appendix 8.

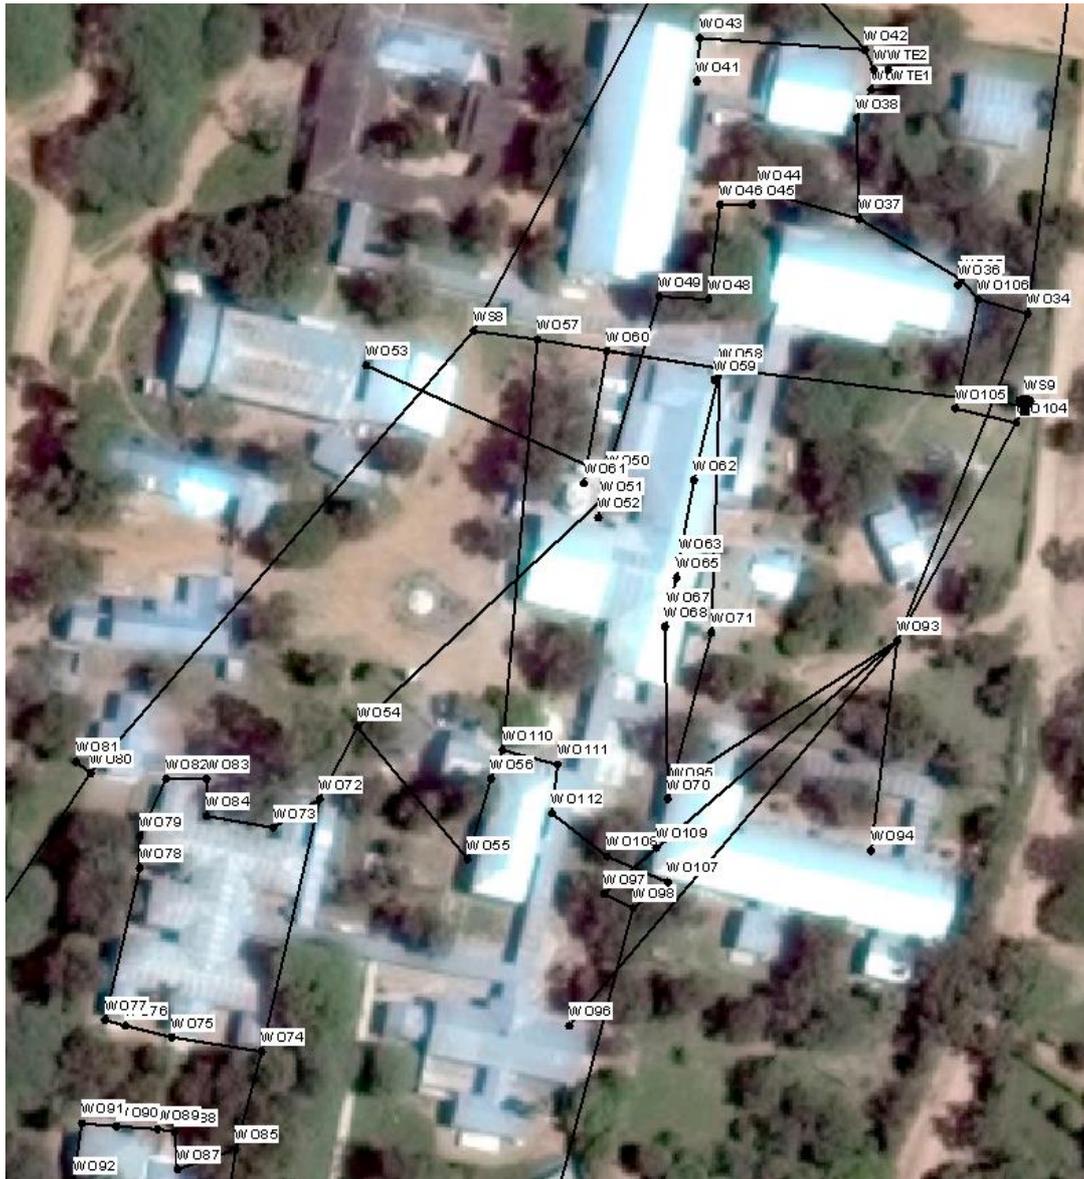
Figure 5: Distribution network at hospital with junction labels from EPANET-model (backdrop from maps.google.com)

Also, the distribution network in the hospital area were mapped, see Figure 5 with Appendix 8 for descriptions. Only junctions, outlets and tanks were mapped, not the actual pipes. Therefore, the lines in the figure only roughly represents the true location for each pipe.

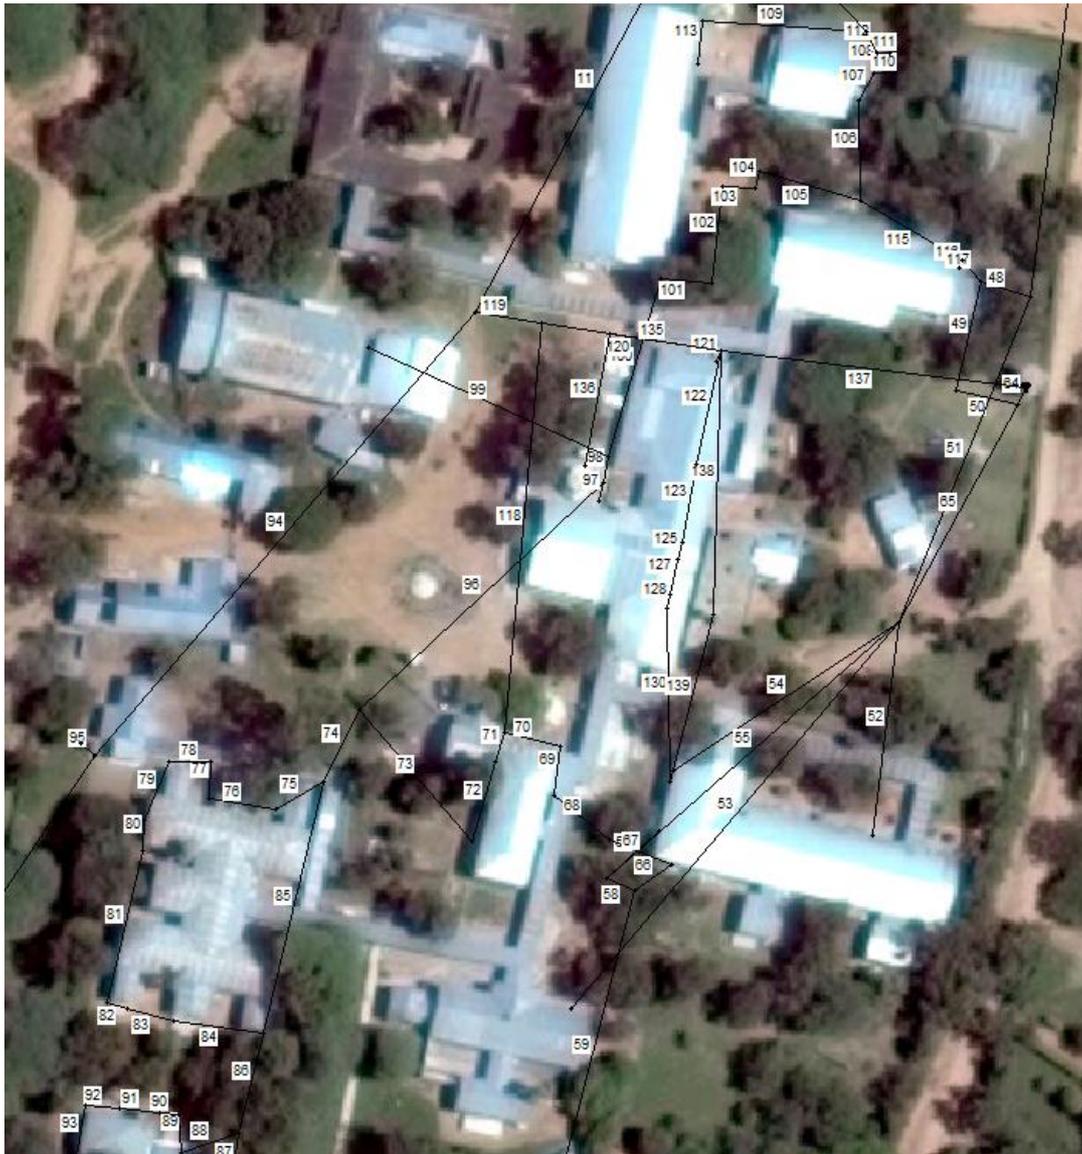
Figure 6: Distribution network at hospital with pipe labels from EPANET-model (backdrop from maps.google.com)

The distribution network consists of different pipes, where material and size alter. See Figure 6 together with Appendix 9 for diameter of each pipe. EPANET has been used in order to determine if the network can handle higher pressure and a higher flow before breaking. Simulations indicates that a higher pressure and therefore a higher flow can be implemented without damaging the pipes.

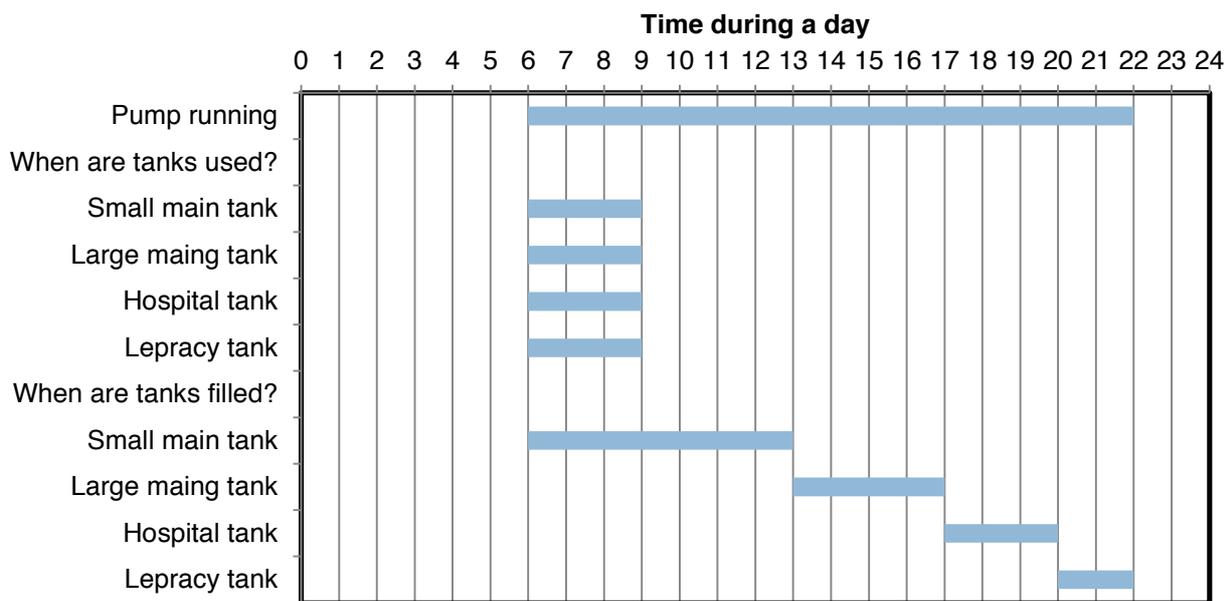
Figure 7: A complete pump and tank schedule, stating when tanks are filled and used.

Today, four people are responsible for the pump. There is always staff present in the pump house, even though the pump is only running from 06 – 22. Groundwater is pumped from the drilled borehole and transported through the distribution network to the tanks. Each tank is filled up at a certain time, see Figure 7. During phase one, a new pump was bought and installed. A new pump schedule was created together with the water staff, presented in Appendix 3.

A pump schedule has been implemented by the responsible staff. Pumping starts at 06.00 and stops at 22.00. A rest time of 8 hours is necessary in order to prevent malfunction of the pump. There is also a more detailed tank filling schedule where the exact time of filling each tank is presented, see Figure 7.

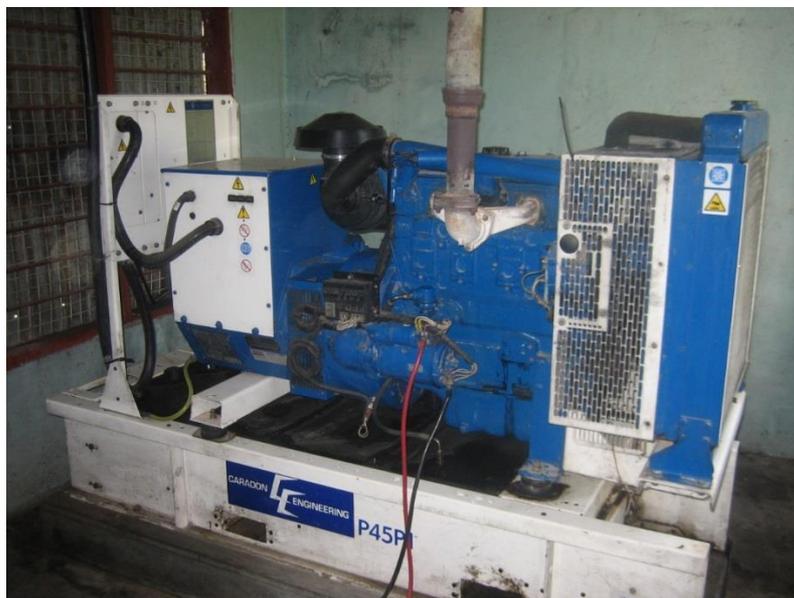
Figure 8: The generator which is currently in use.

The main reason for not using the generator every time the city power breaks down is economy. It is very expensive to use a generator for this amount of time.

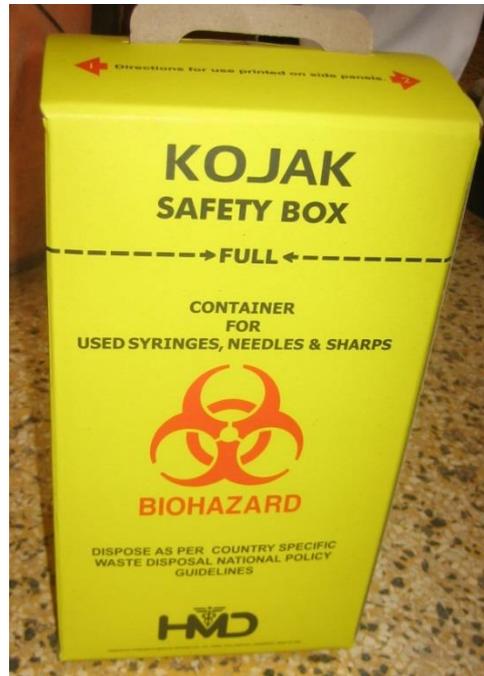
Figure 9: "Kojak safety box" for disposal of used syringes, needles and sharp objects.

Normally the buckets are in the size of 20 l, even though 50 l buckets are used for the non-dangerous waste in the general ward. In addition to this, used syringes and sharp equipment are disposed in yellow well-pap “Kojak safety boxes”, specially designed for the purpose, see Figure 9.

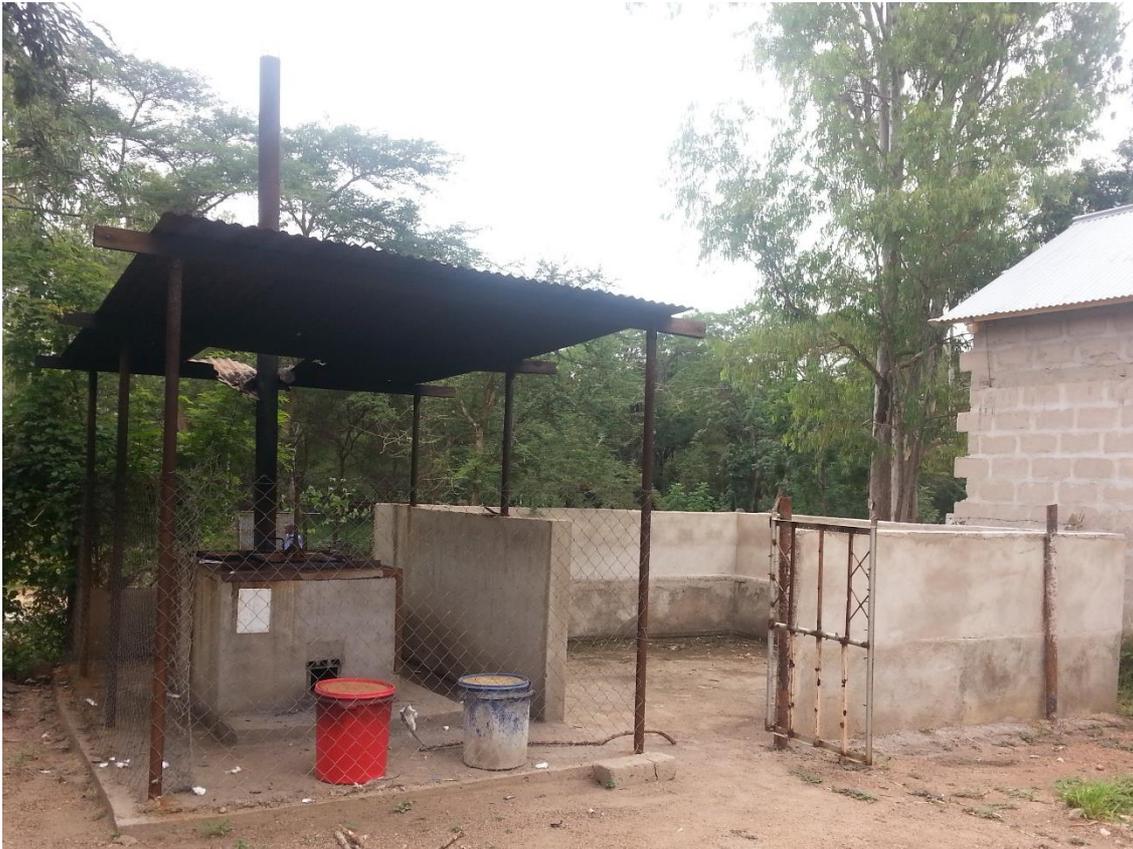
Figure 10: Waste area, including the incinerator and the area without roof.

The area next to the incinerator could allow stocking up waste and burn in bulks during night time when less persons is present in the area and the hospital's activity is low. However, this is not used since it is lacking a roof and rain would wet the waste and inhibit the burning, see Figure 10. The waste is instead continuously burned throughout the day as it is received.

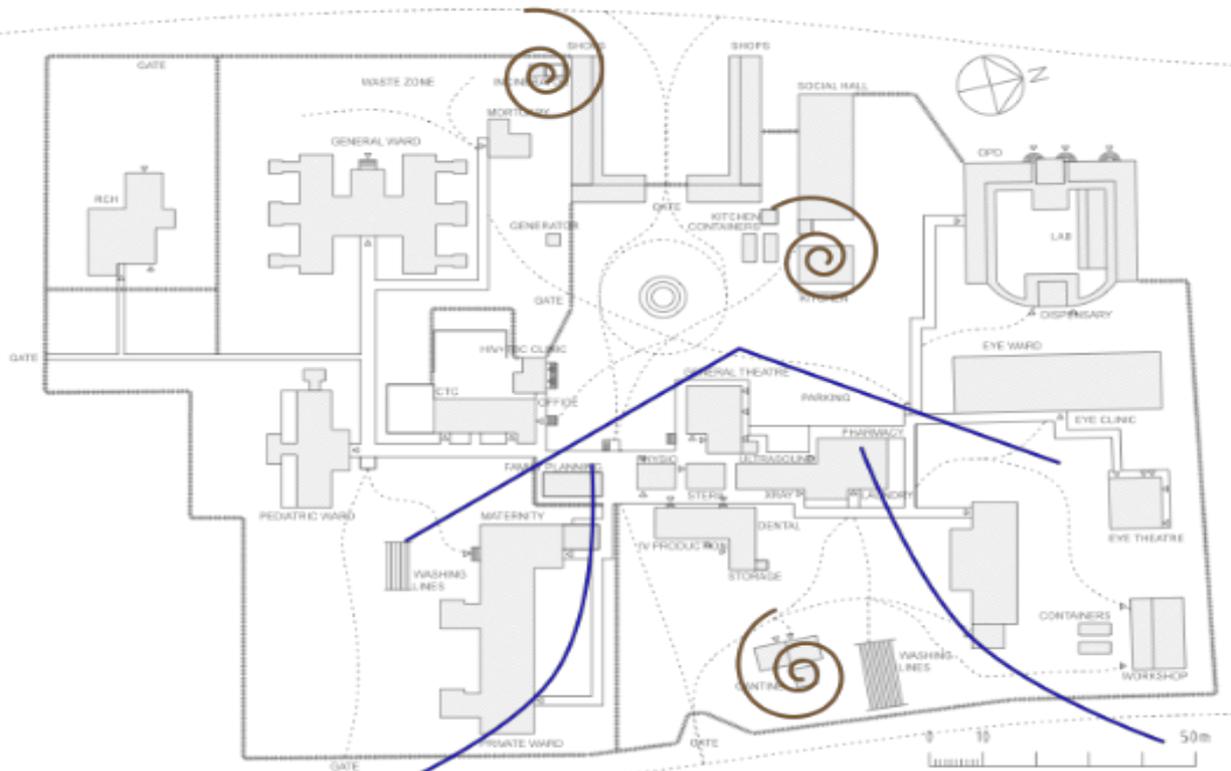
Figure 19: Air flow

The prevailing wind is coming from northeast-northwest going to southeast-southwest across the hospital area. This affects the spread of smoke throughout the site. The main sources of smoke are the incinerator, the kitchen and the canteen. Two of them are situated toward the west side of the hospital area which means that the flow of smoke most often exits the hospital fast. However, the road immediately west of the hospital is highly affected by the smoke. The amount of smoke from the canteen is little in comparison to the smoke from the kitchen and the incinerator. See the complete air flow illustration in Figure 19.

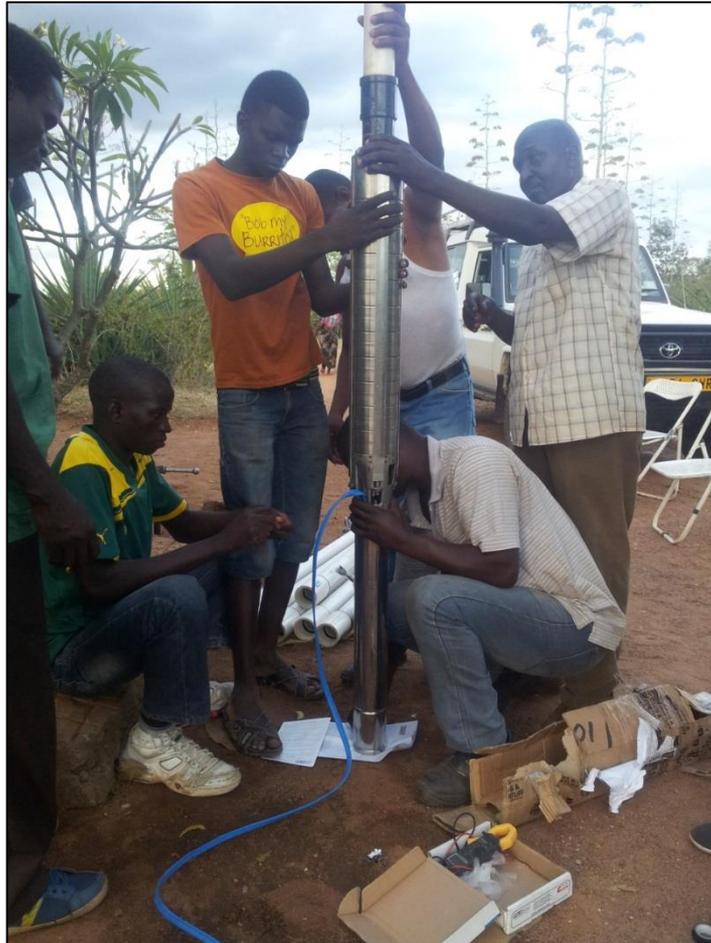
Figure 26: Installation of new pump

Also, a new pump schedule was created together with the water staff, presented in Appendix 3.

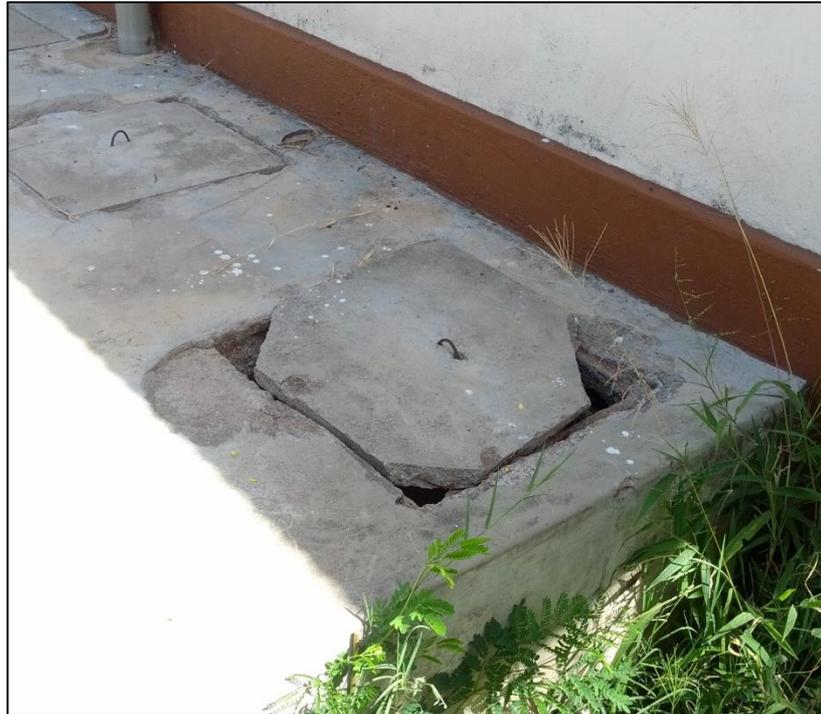
Figure 27: Broken hatch on a septic tank, located close to the maternity ward.

There are two different hatches at the hospital, one in metal and one in concrete. A hatch made out of concrete is cheap and can be constructed at the hospital. The metal hatch is more expensive and need to be purchased from Shinyanga. However, the lifespan of the metal hatch is significantly longer, and Julius Omango, the staff responsible for wastewater issues, recommended the usage of metal. Julius Omango estimated the cost for a metal hatch to approximately 20 000 TZS.

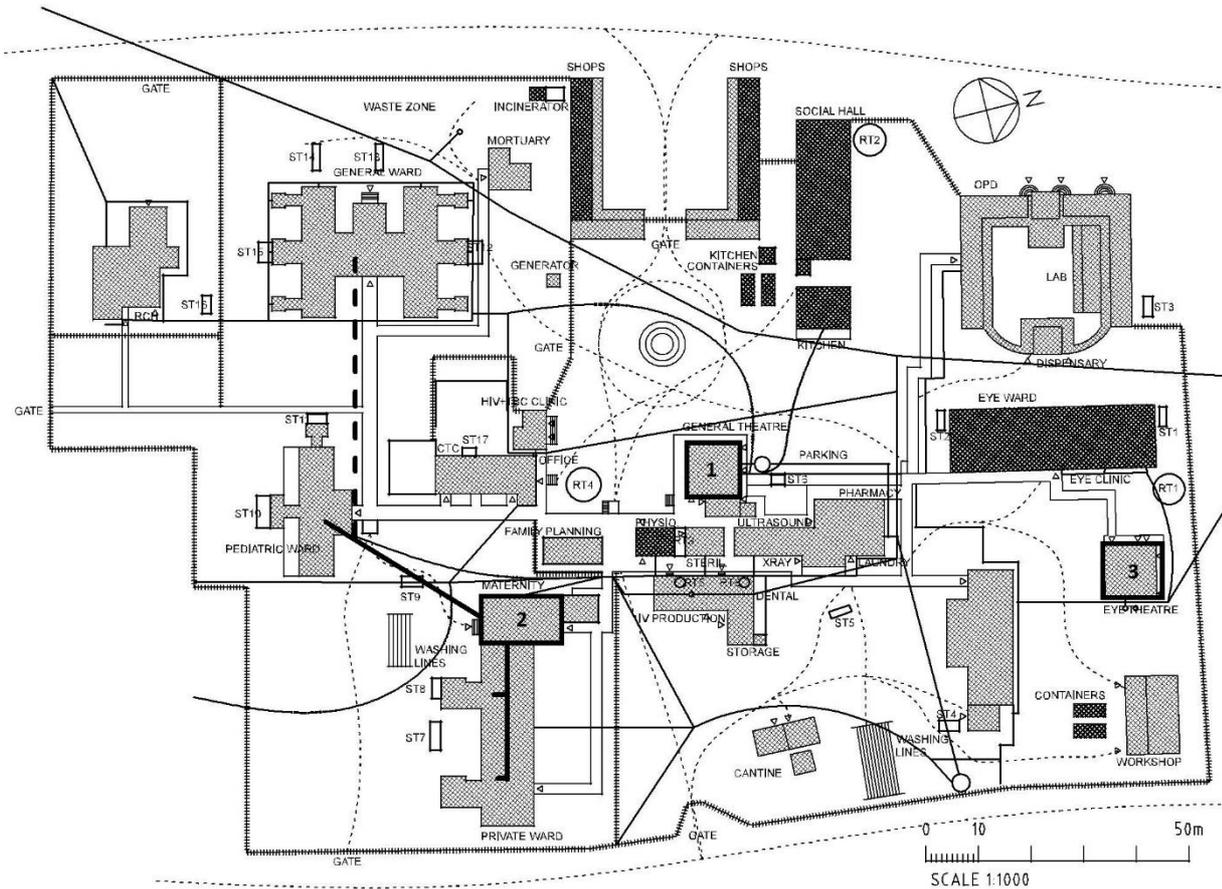
The backup system should be designed as three separated systems: (1) general theatre, (2) maternity theatre (including delivery room), and (3) eye theatre, i.e. three decentralized systems with one set of solar panels, batteries and inverters at each site, see Figure 28.

Figure 28: Overview map over Kolandoto Hospital with areas to be provided with solar power: (1) general theatre, (2) maternity theatre and delivery room and (3) eye theatre.

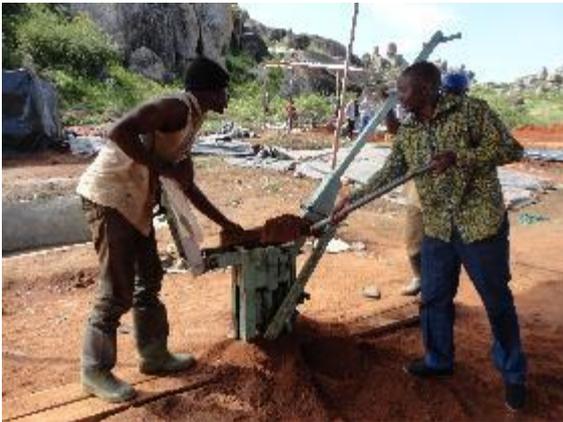
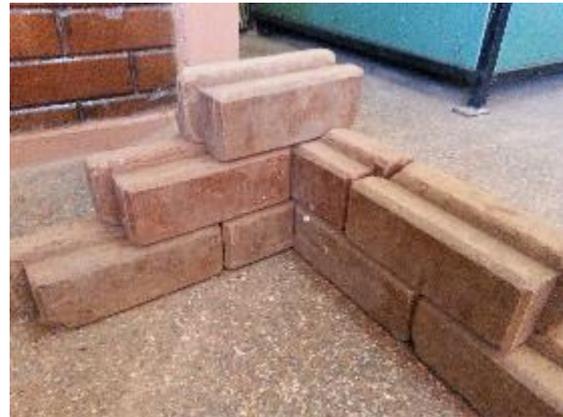
Figure 30: ISSB machine

In Nairobi, I (Annika), went on a study visit to an engineering company that makes block presses used for producing interlocking stabilized soil blocks (ISSB), called Makiga Engineering. There are several benefits with using the ISSB blocks and machine illustrated in Figure 30. First, is that the cost of the building will be drastically less than when building with for example cement blocks, due to that the soil block technique will require much less cement to make, and the interlocking building technique requires very little mortar in comparison to non-interlocking. Second, the material used for construction of a building can most often be the soil existing on the site, which also reduces the cost of construction as well as minimizes transport of materials. Third, the machine takes four people, with a little bit of training, to operate which means that you bring an income generating activity to the local community using the technique. A complete brochure from Makiga Engineering is attached in Appendix 26. The price list from Makiga Engineering is in Appendix 27. In addition to the cost of buying the machine, one also has to budget for transport and import costs, as well as training costs in operating the machine.

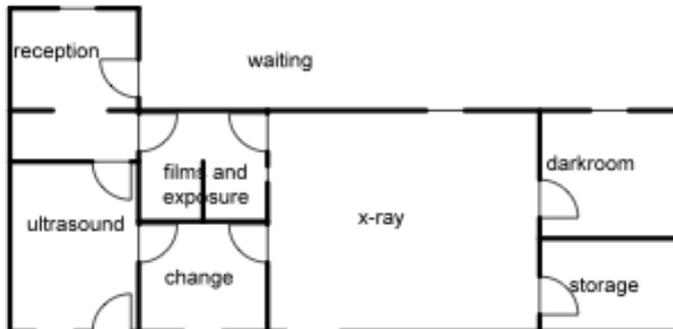
Figure 32: Current layout

Problem description: The layout of the imaging department today, Figure 32, is a problem since the doors for entering the department are too narrow for a stretcher to go through without trouble. This means that there are situations in which patient who cannot walk have to be carried on his/hers mattress to be able to enter the x-ray room. This is troublesome, dangerous and painful for the patients who sometimes are severely injured. The current entrance situation also causes the patients going for x-ray to have to enter and then turn back 180 degrees in the building which makes taking an x-ray even more troublesome for the patient and the staff.

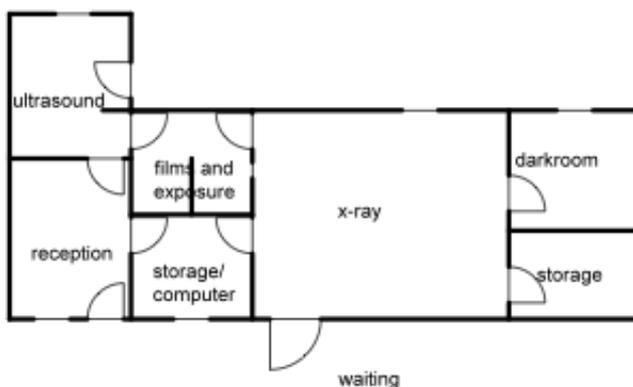
Figure 33: Proposed reorganization

Proposal: The proposal, in Figure 33, includes changing the layout of the imaging department to facilitate for an easier and not dangerous entrance situation for patients. The proposal includes three modifications to the building: 1) Exchanging a current window in the x-ray room to become a door. This window is 1260 mm wide, and the staff express that a door this size would also be enough for patients on stretchers. 2) Remove one old piece of a wall in the current reception room to make the room have enough space for accommodating ultrasound examination activities. Before making this one has to ensure that the stability of the building structure is not affected. 3) Building a floor and roof for the new waiting area. It is an area of 2.8 m times 5.1 m. This probably requires four new pillars.

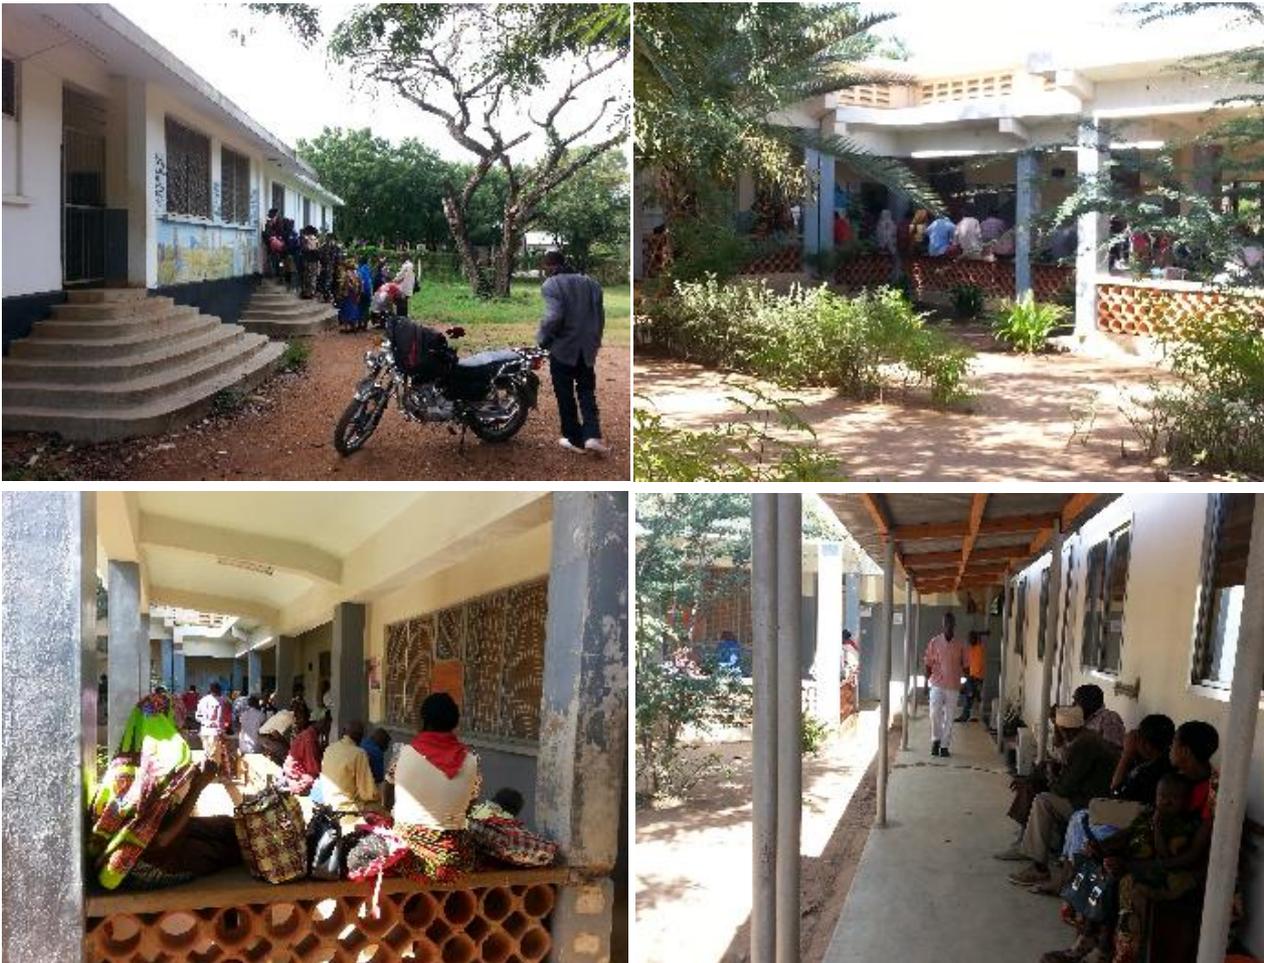
Figure 34: Current waiting areas at OPD

Problem description: The area for waiting at the outpatient department building, see Figure 34, is often overcrowded - both before registration outside the outpatient (OPD) building, and after registration waiting for the seeing the doctor inside the OPD.

Proposal: The suggestion is to build new and/or extended waiting areas for patients both inside and outside the OPD building. However, this need was not fully identified until late during the study visit and hence there is no design proposal for how to do this. To make new waiting areas at the OPD requires a process of size estimation, assessment of technical preconditions of the building, design proposals, detailed budget and then implementation.

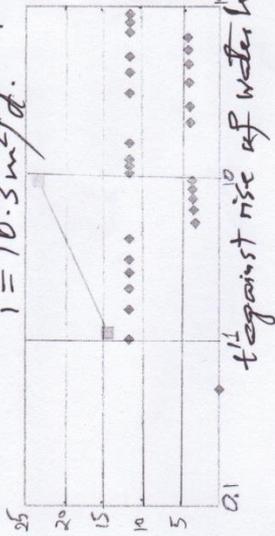
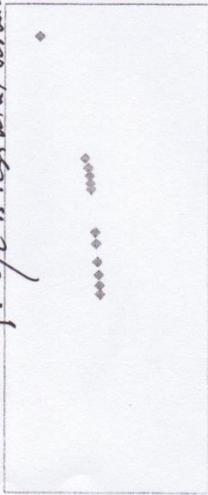
Recovery: t/t_0 residual drawdown

Recovery Transmissivity
 $\frac{1}{1} = 10.3 \text{ m}^2/\text{d}$

The Recovery Transmissivity value is fairly high, which gives a range of $10.3 \text{ m}^2/\text{d}$. This indicates a very good aquifer material which releases its water very easily.

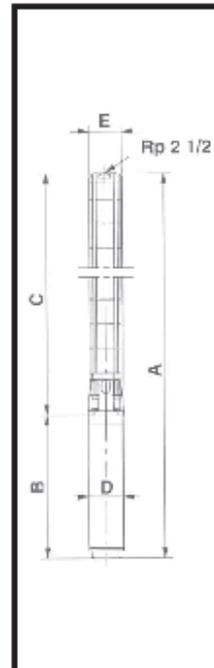
Model	Dimensions (mm)				Weight (Kg)
	A	B	C	E*	
DS 17-7	1320	614	706	131	36.7
DS 17-10	1571	684	887	131	44.6
DS 17-13	1833	764	1069	142	53
DS 17-17	1996	685	1311	142	77.2
DS 17-20	2222	730	1492	142	85.5
DS 17-24	2519	785	1734	142	97.3
DS 17-27	2701	785	1916	142	101.7

E*—Maximum diameter of the pump inclusive of cable guard and motor
